Aircraft Accident Investigation Report

PT Sriwijaya Air

Boeing 737-500; PK-CLC

9 January 2021

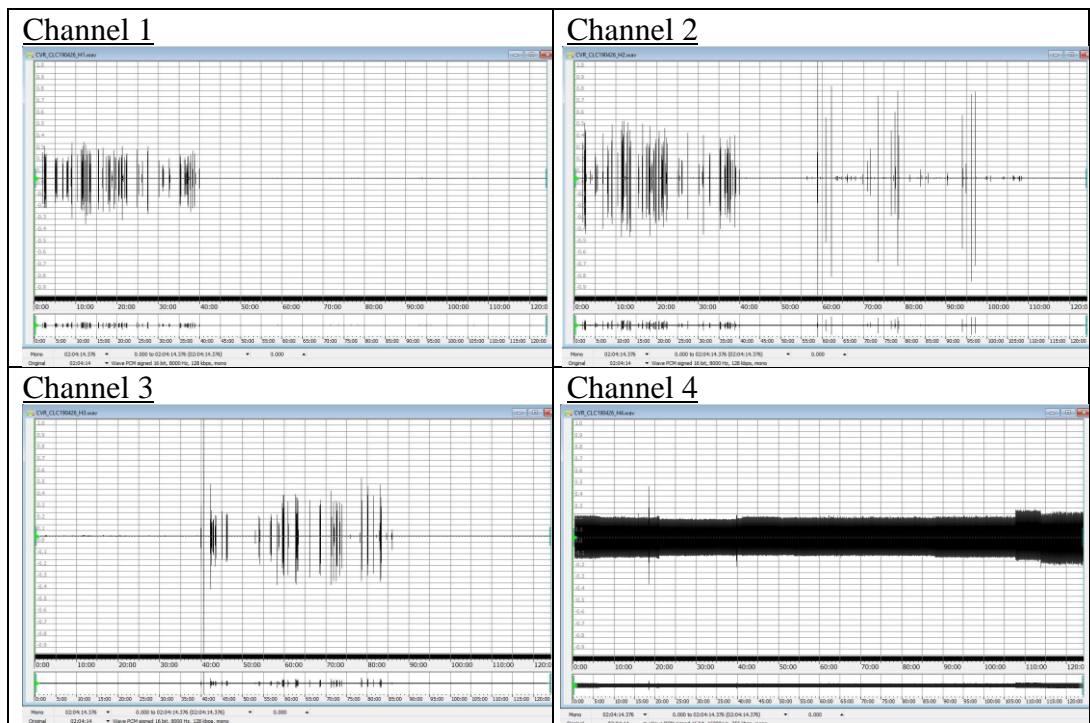
Figure 14: The downloaded CVR data in 2019

The CVR P/N 2100-1020-00 with S/N 000286507 data was downloaded in 2019 and 2020 for the renewal of the Certificate of Airworthiness (C of A) which in 2019, the CVR download was performed at the Garuda Maintenance Facility. The downloaded audio from the Channels 1, 2 and 3 were normal while the Channel 4 recorded a prominent tone with a frequency of about 400 Hz. The result of the download stated that the CVR was functioning correctly.

The investigation was unable to determine the reason on why Channel 4 recorded a prominent tone with a frequency of about 400 Hz in the downloaded CVR data in 2019 but was not in the downloaded CVR data in 2020.

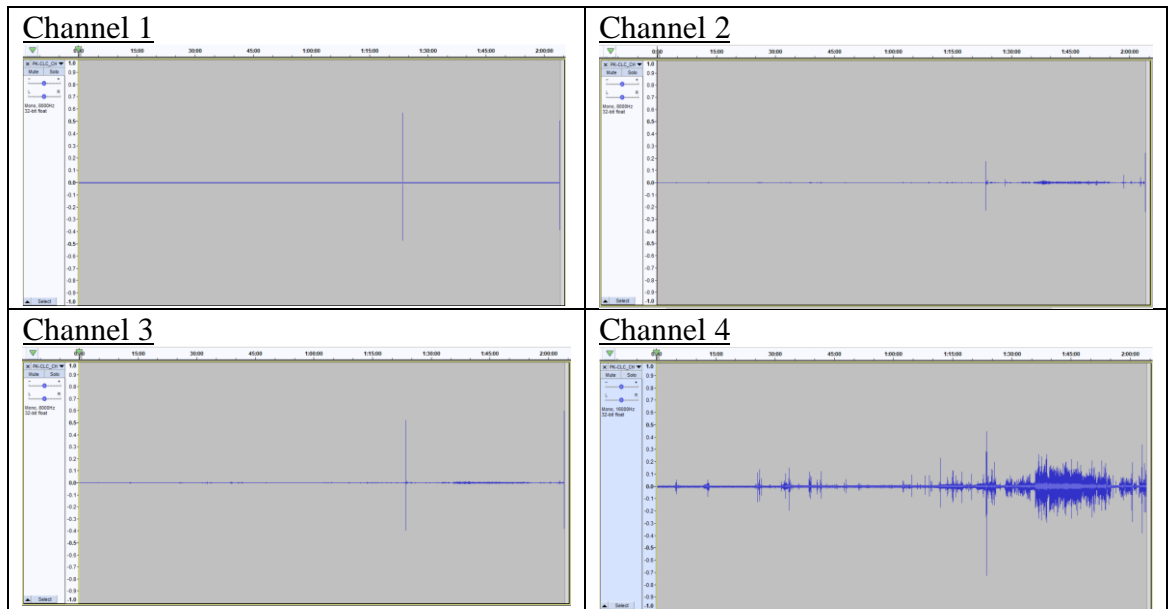
Figure 15: The downloaded CVR data in 2020

On 9 April 2020, the CVR was downloaded at the Sriwijaya Air facility while the aircraft was grounded for maintenance. There was no recording on Channels 1, 2 and 3, while Channel 4 recorded conversation between engineers while performing maintenance. The result of the download stated that the CVR was functioning correctly.

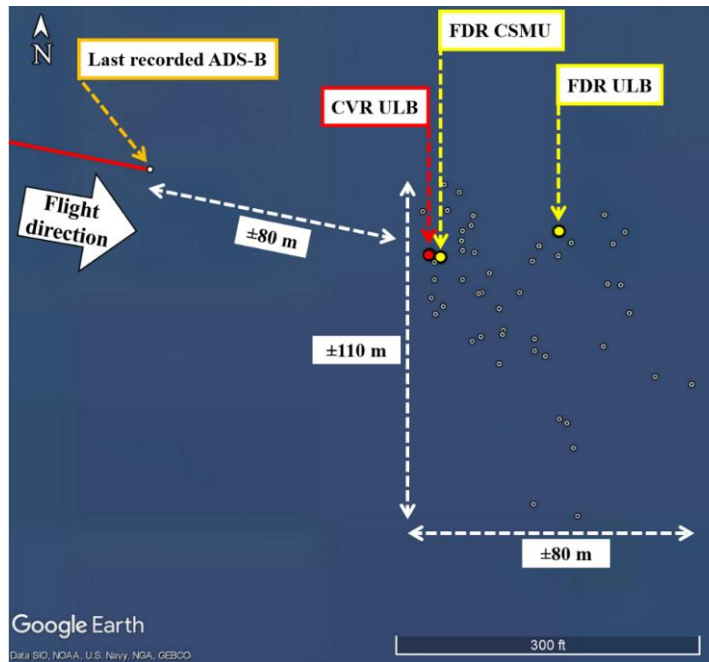
Figure 17: Location of FDR CSMU, FDR ULB and CVR ULB relative to the last ADS-B recorded data

The FDR’s CSMU was found within the wreckage distribution area at coordinates 5°57’51.00” S 106°34’31.00” E. The ULBs were detached from both the FDR and the CVR¹⁵. The FDR’s ULB was found at coordinates 5°57’50.76” S 106°34’32.10” E approximately 35 meters from the FDR’s CSMU, and the CVR’s ULB was found at coordinates 5°57’50.98” S 106°34’30.90” E.

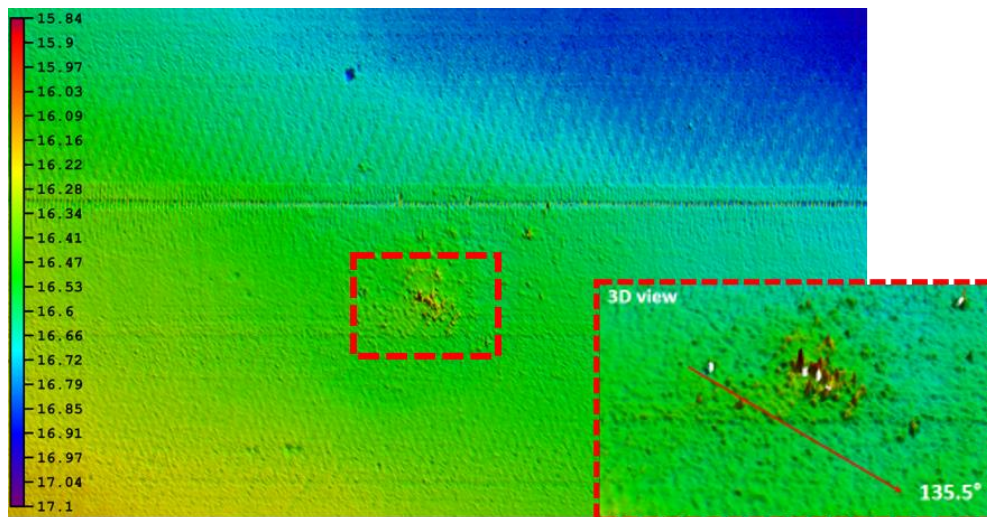
Figure 18: Scanning result from multibeam echosounder

The accident site was located about 11 Nm northwest of Jakarta, and about 80 meters southeast of the last known aircraft position recorded by the ADS-B. The wreckage distributed over an area of about 80 by 110 meters on the seabed at a depth of approximately 16 meters.

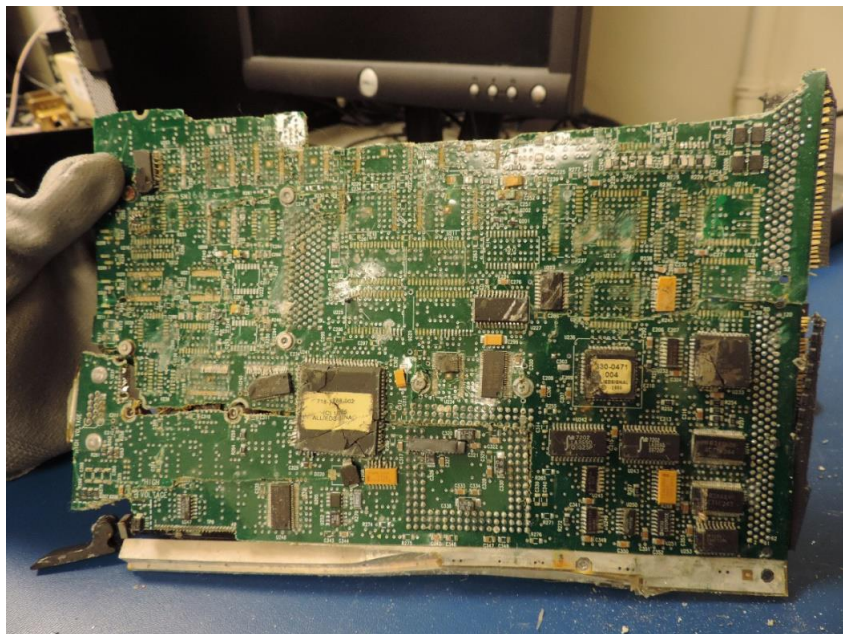
Figure 19: The EGPWS CCA

The unit was examined at the Honeywell Aerospace facility in Redmond, Washington, USA on 8 April 2021. The examination revealed that the unit was severely damaged with sections of the chassis and circuit card assemblies missing, deformed, and scratched. The mounting tray was still in place with the unit and could not be removed by hand. To remove the unit from the tray, the rivets that held the mounting tray were removed, and a section of the tray was cut to remove the EGPWS computer.

The EGPWS Circuit Card Assemblies (CCA) were removed from the chassis of the computer and inspected. The EGPWS CCA condition is shown in the following figure.

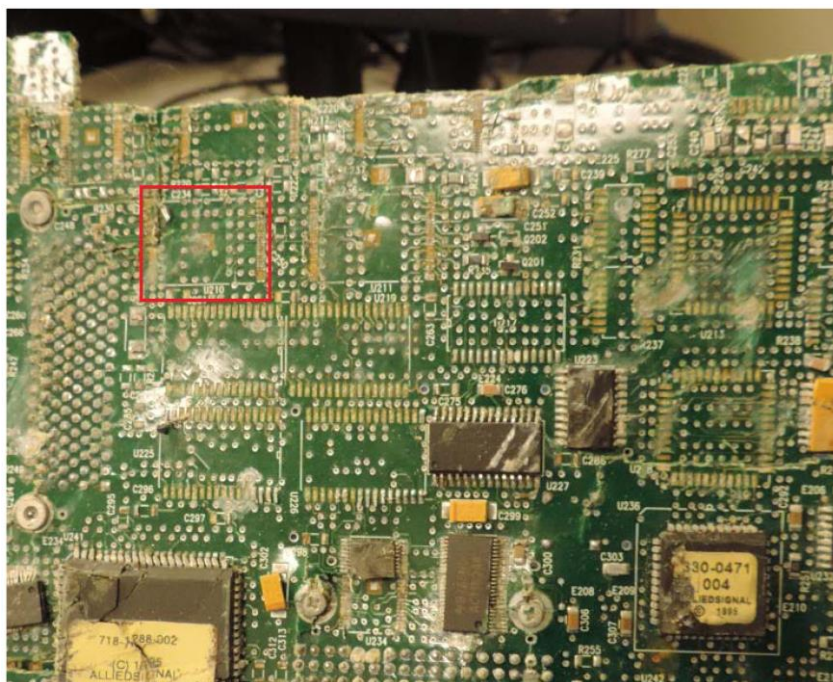
Figure 20: The red box is to identify the missing EGPWS A2 CCA chip

In this version of EGPWS computer, flight history data is stored in the memory chip on the controller A2 CCA. Some components were missing from the A2 CCA, including the memory chip. The location of the missing A2 CCA memory chip is shown in the following figure.

As the memory chip was not recovered, no further examination was conducted to the unit and no flight history data could be retrieved.

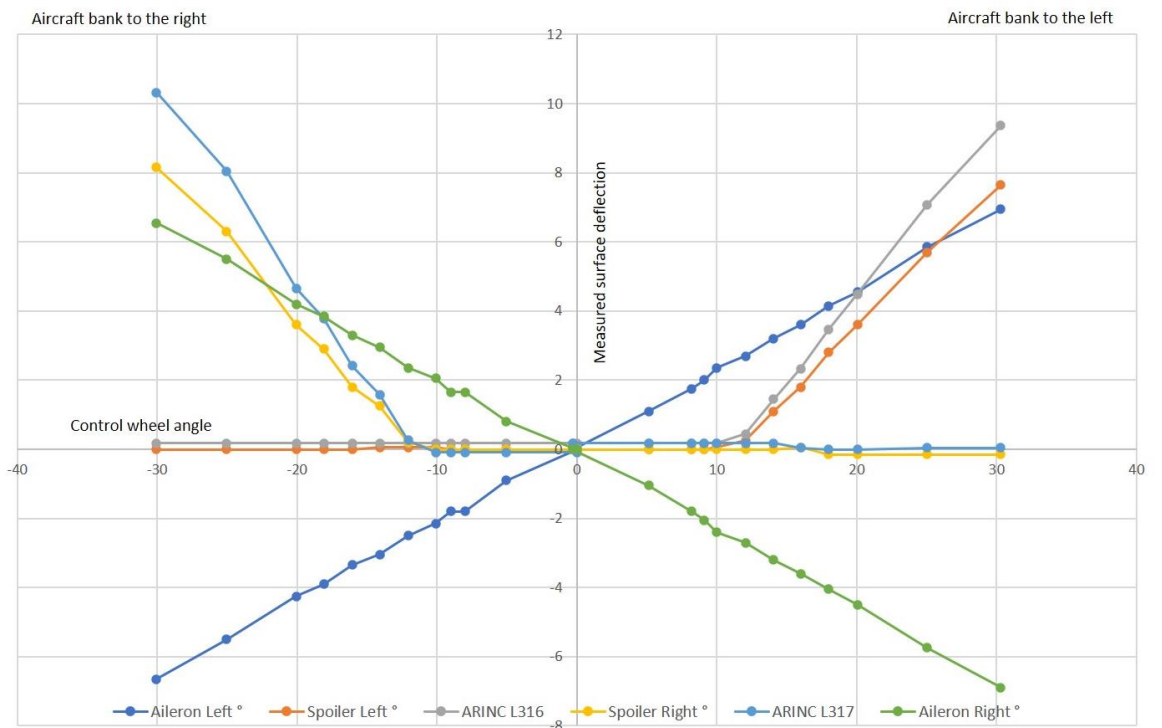
Figure 22: Aileron and spoiler deflection test result (surface deflect up = positive value)

The test verified that the spoiler position angle matched to the spoiler position output from the FCC. The relationship chart of the aileron and flight spoiler deflection is shown in the figure below.

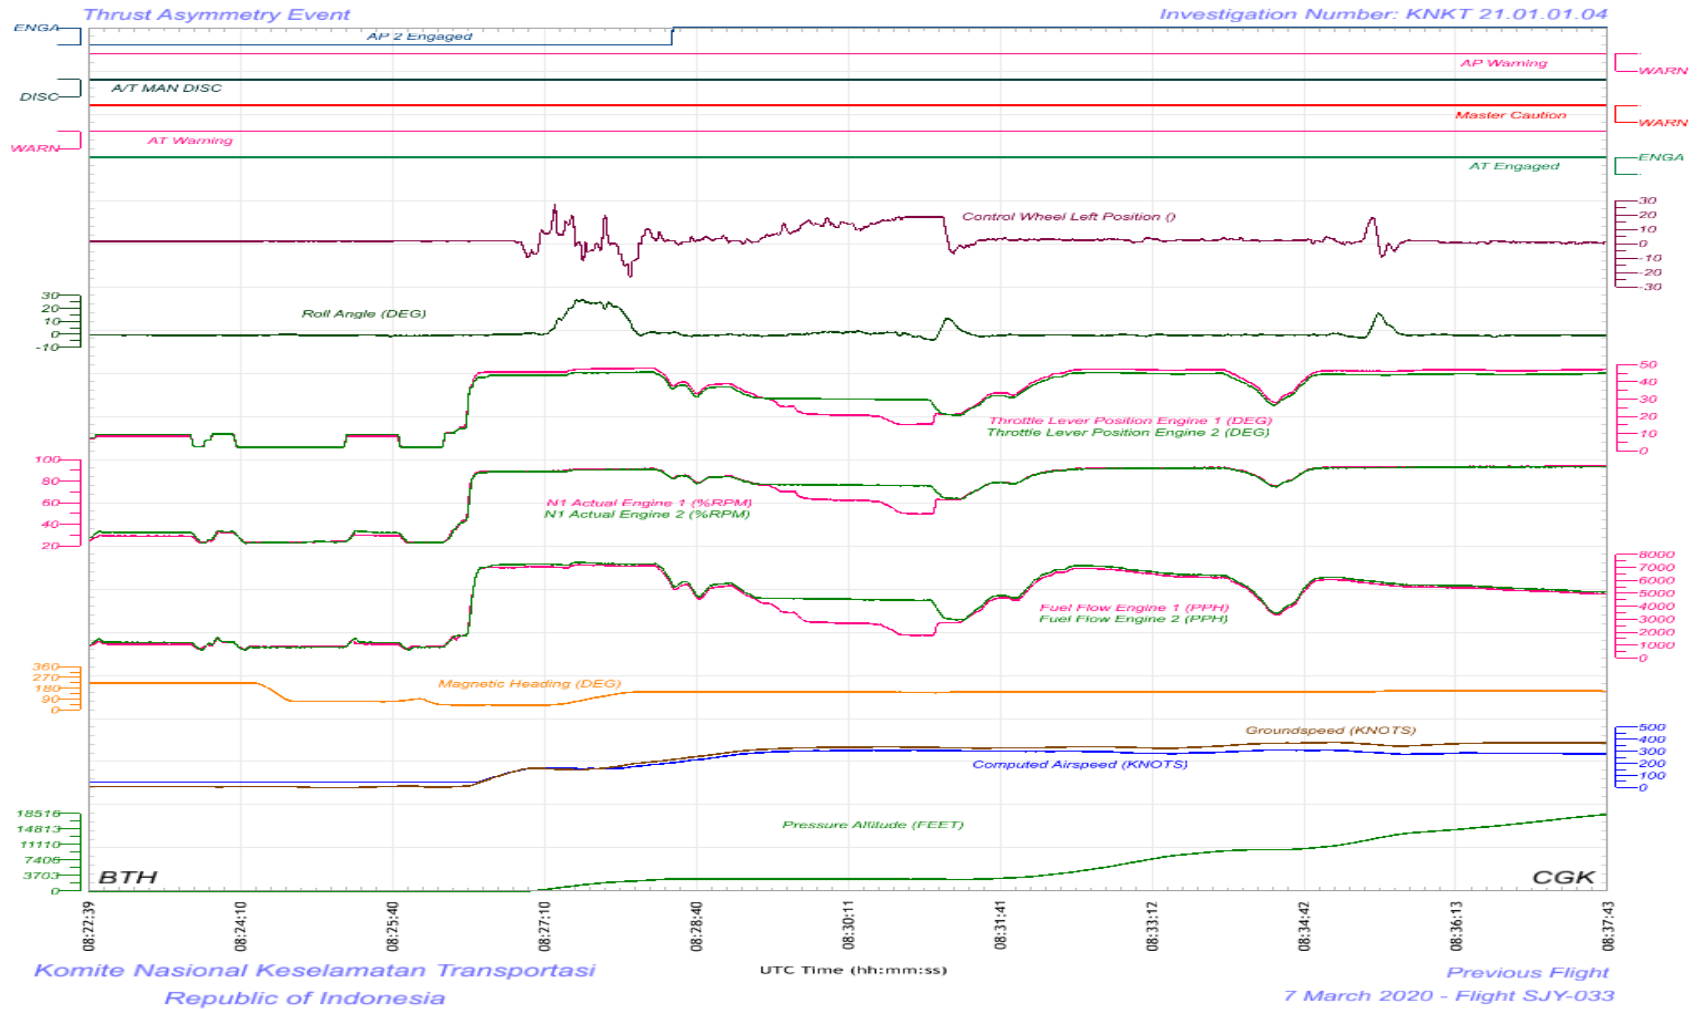
Figure 31: The QAR data of a flight on 7 March 2020

The investigation retrieved the downloaded QAR data of PK-CLC aircraft from the aircraft operator. The QAR data of PK-CLC recorded several flights that experienced abnormal movement of thrust levers and the first occurrence of abnormal movement of thrust levers was on 7 March 2020. The QAR data are as follows:

The QAR data of a flight on 7 March 2020 showed that:

The investigation team has interviewed both pilots of this flight. None of the pilots recalled the asymmetric power event. No pilot report was filed into the AML for this flight.
