Aircraft Accident Investigation Report

PT Sriwijaya Air

Boeing 737-500; PK-CLC

9 January 2021

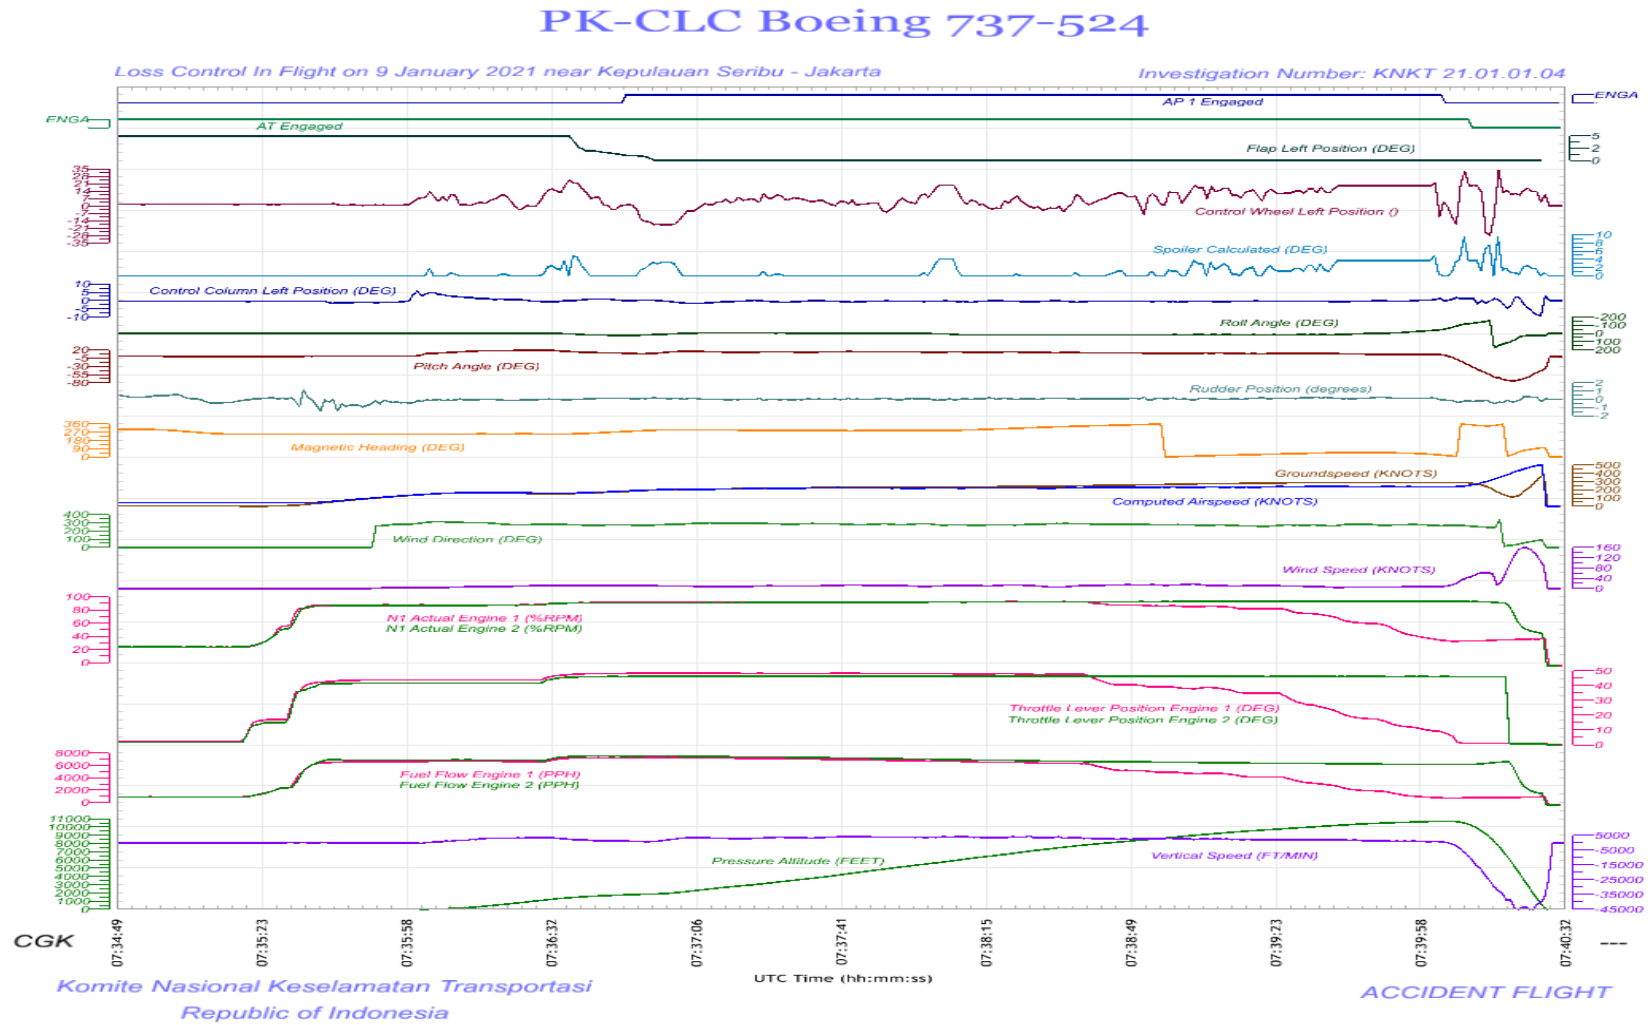
Figure 10: The significant FDR parameters of flight instrument of the accident flight

The FDR did not record the aircraft rate of climb/descend and the spoiler deflection angle. The data for these parameters in this investigation report were based on calculation. Boeing estimated the flight spoiler positions by correlating the spoilers to the control wheel positions recorded on the FDR. The calculation assumed nominal aircraft rigging and a neutral aileron trim setting, which could not be verified for the accident flight.

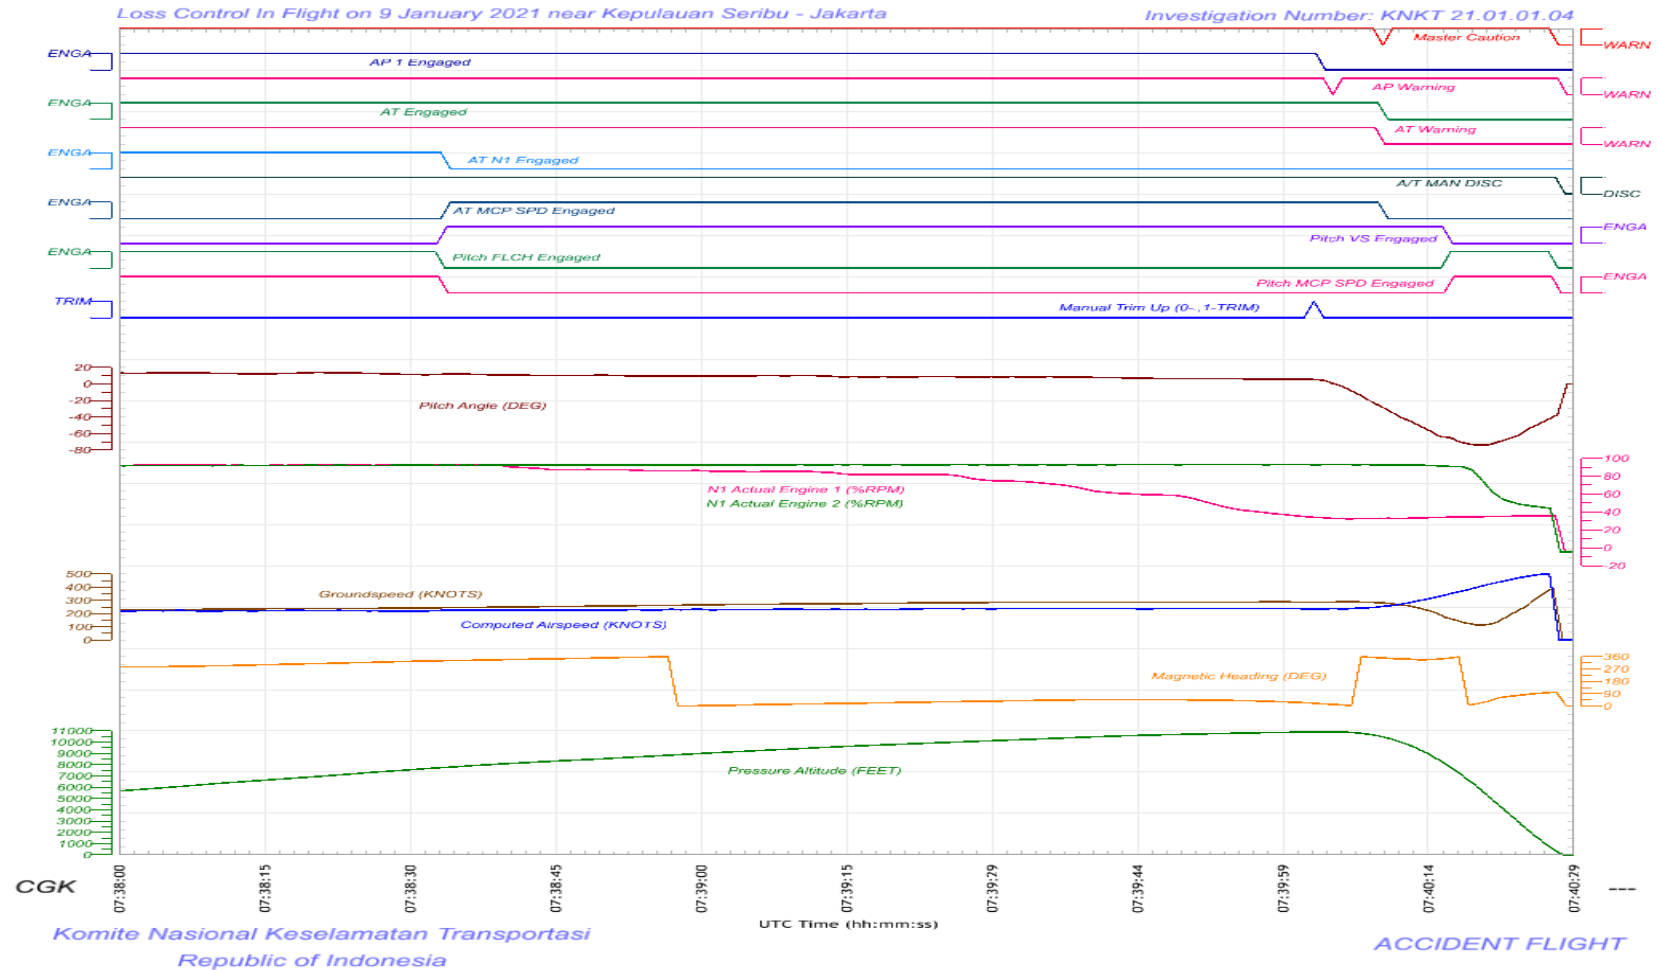
Figure 13: The significant FDR parameters of autoflight of the accident flight prior to thrust lever split until the end of the flight

The FDR data showed that:

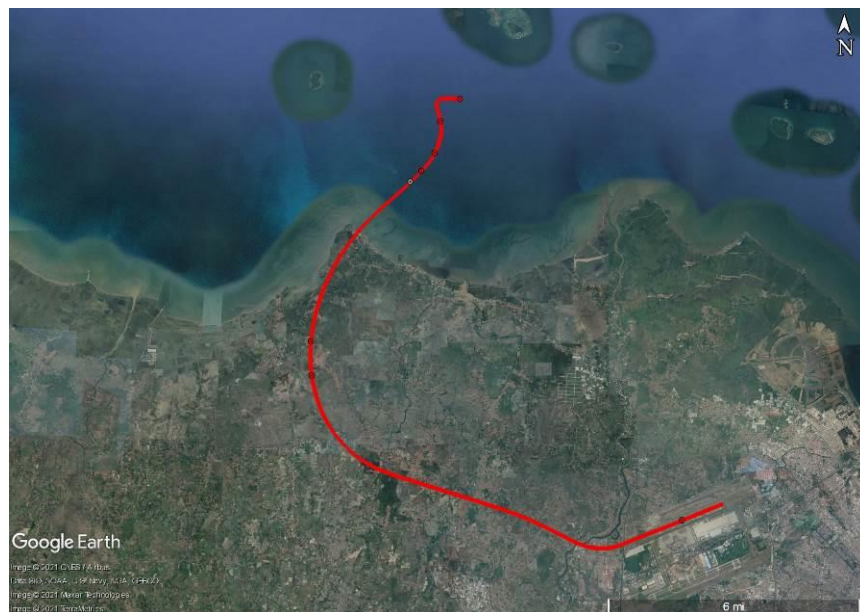
Figure 16: Aircraft flight track based on the FDR imposed to Google Earth

The accident site was located about 11 Nm northwest of Jakarta, and about 80 meters southeast of the last known aircraft position recorded by the ADS-B. The wreckage distributed over an area of about 80 by 110 meters on the seabed at a depth of approximately 16 meters.

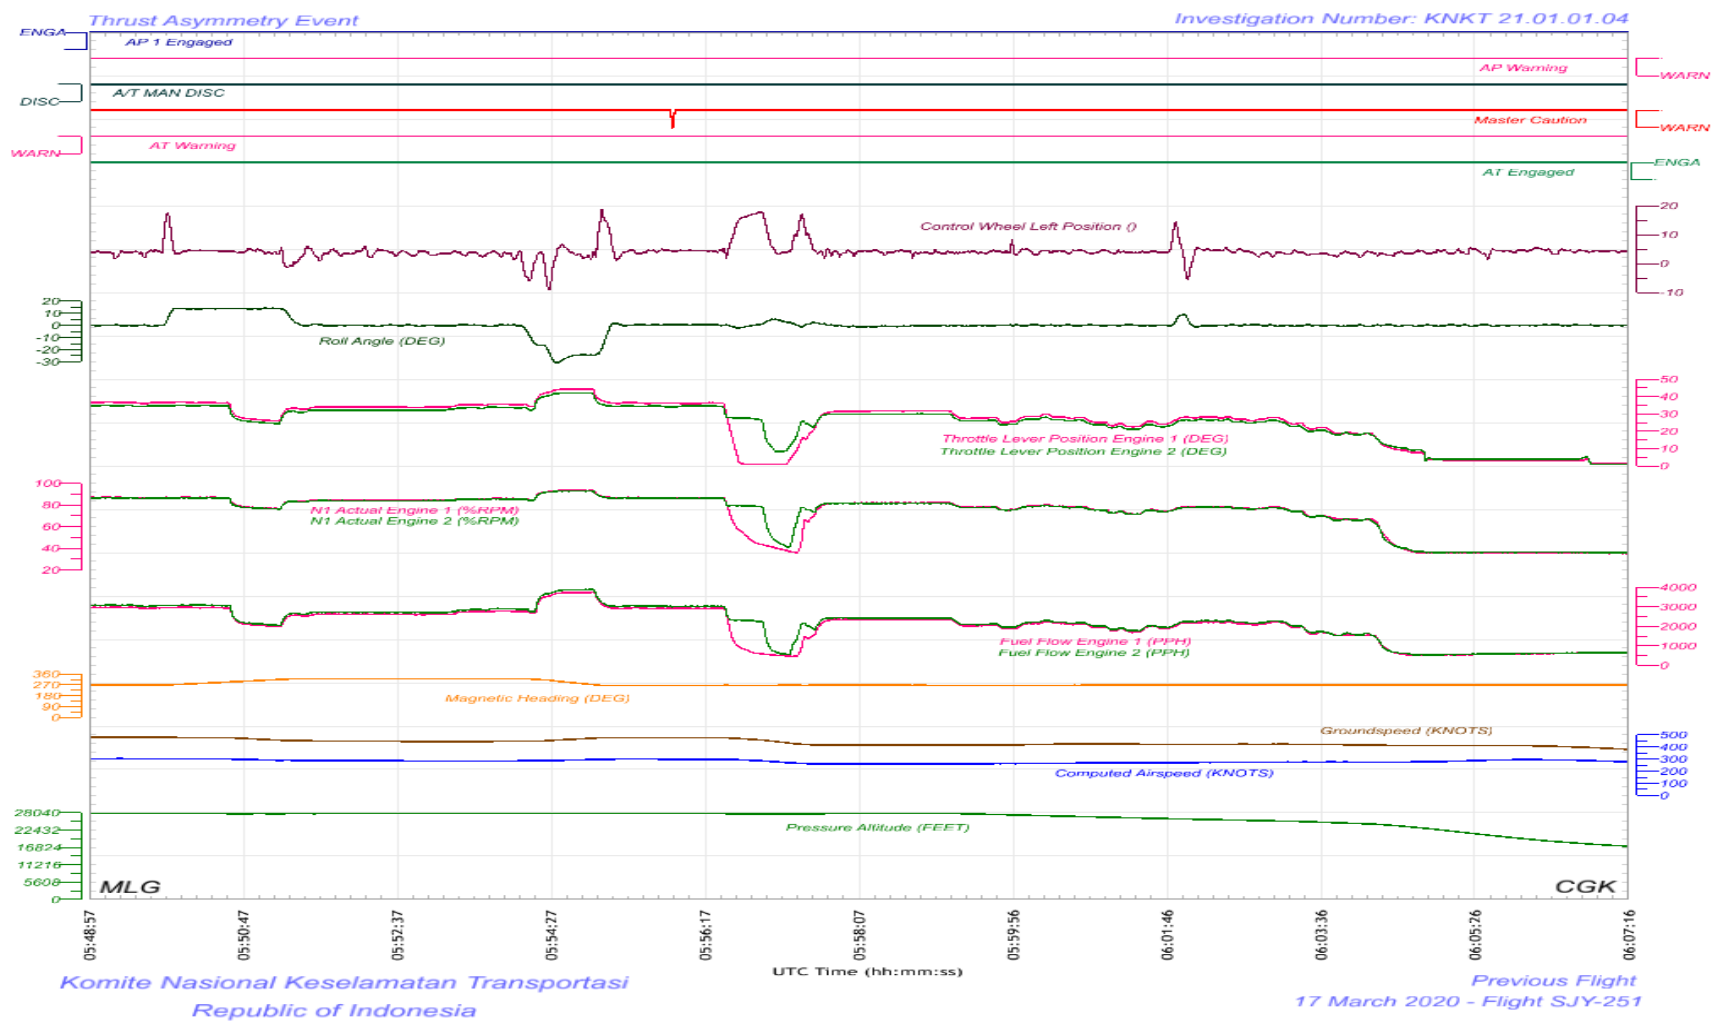
Figure 35: The QAR data of a flight on 17 March 2020

The QAR data of a flight on 17 March 2020 showed that:

No pilot report was filed into the AML after this flight.

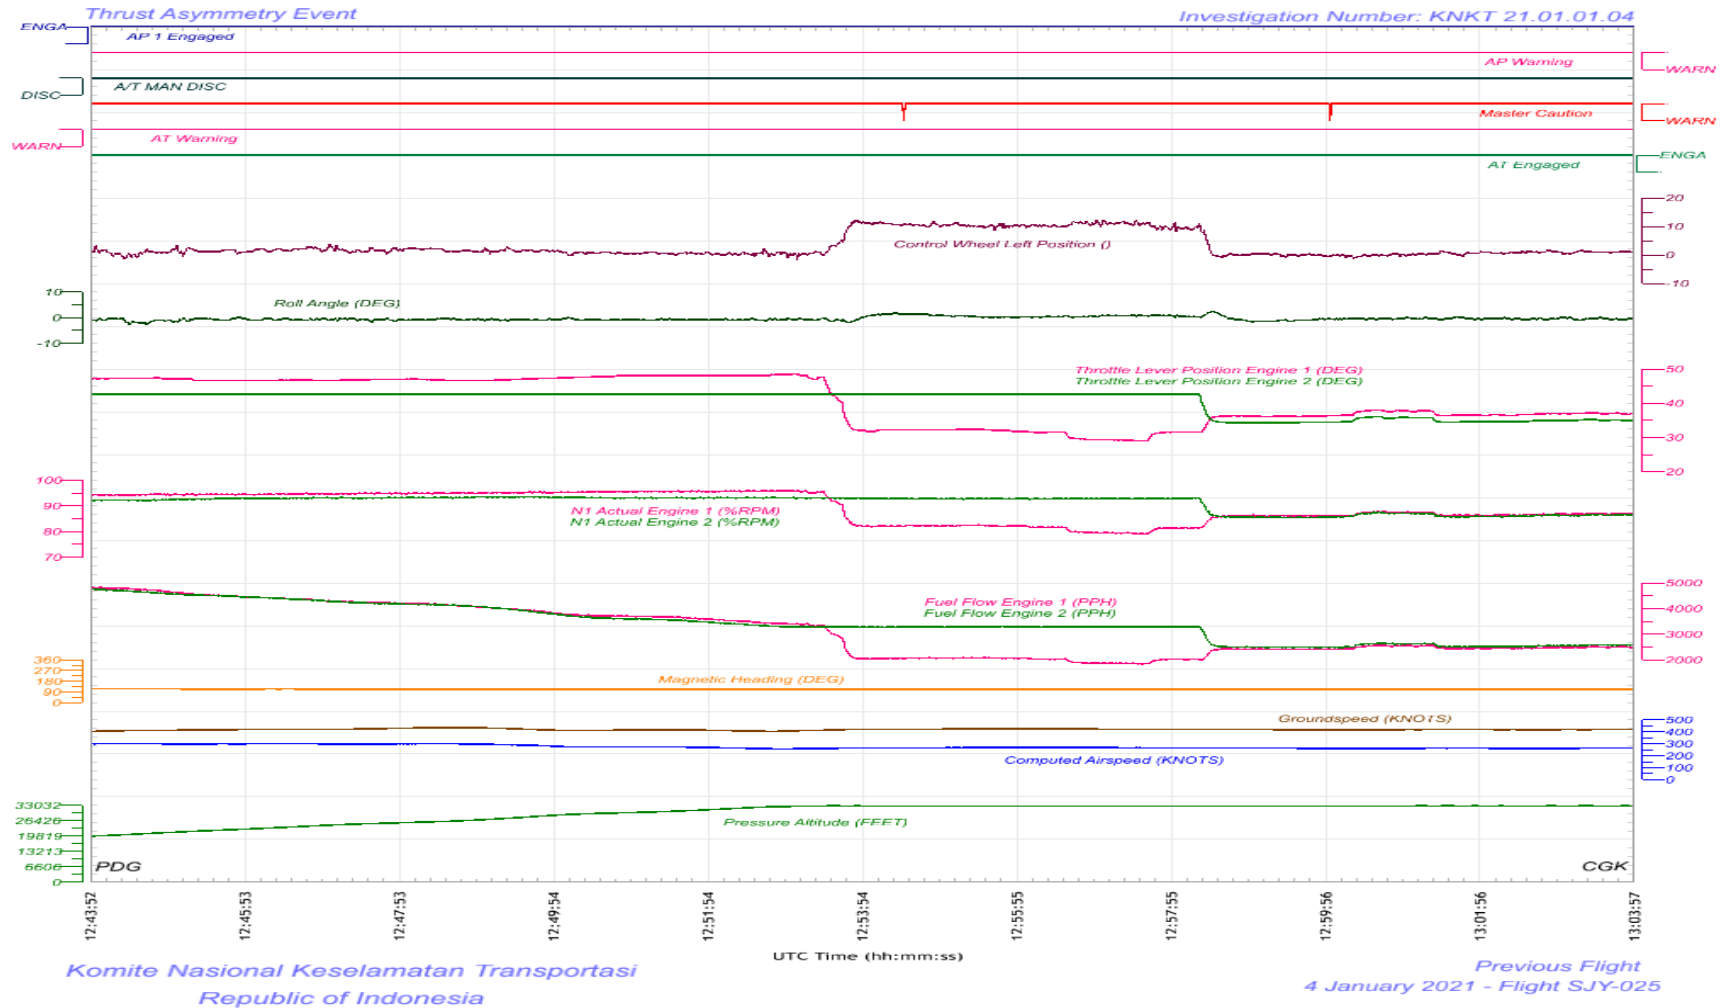
Figure 36: The QAR data of a flight on 4 January 2021

The QAR data of a flight on 4 January 2021 showed that:
